Evaluation Report 273

George White Model T610 Field Sprayer

PRAIRIE AGRICULTURAL MACHINERY INSTITUTE

GEORGE WHITE MODEL T610 FIELD SPRAYER

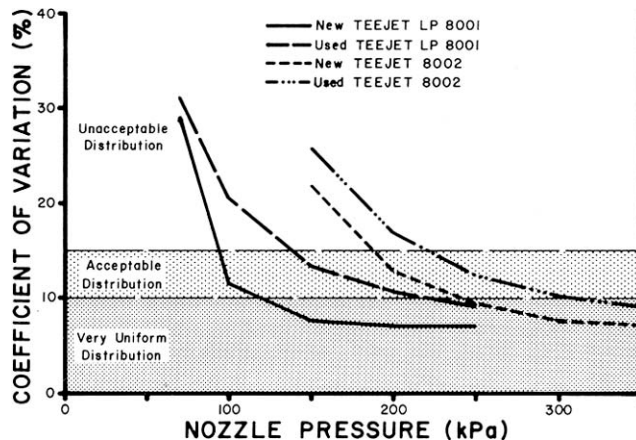
FIGURE 6 shows how nozzle pressure and wear affected spray pattern uniformity for the low pressure 8001 and standard 8002 flat fan nozzles. New LP 8001 stainless steel nozzles produced acceptable distribution patterns at pressures above 95 kPa (14 psi) and very uniform patterns at pressures above 120 kPa (17 psi). After 72 hours of field use, a pressure of 140 kPa (20 psi) was required to produce an acceptable distribution pattern and a pressure of 225 kPa (33 psi) was required to produce a very uniform distribution. Pressures above 200 kPa (30 psi) are not recommended due to excessive spray drift.

New 8002 stainless steel nozzles produced acceptable distribution patterns at pressures above 190 kPa (28 psi) and very uniform patterns at pressures above 240 kPa (35 psi). After 15 hours of field use, a pressure of 220 kPa (32 psi) was required to produce an acceptable distribution pattern and a pressure of 310 kPa (45 psi) was required to produce a very uniform distribution.

FIGURE 6. Spray Pattern Uniformity for New and Used Spraying Systems Tee Jet Standard 8002 and Low Pressure 8001 Stainless Steel Nozzles, Operated at a 460 mm Nozzle Height.

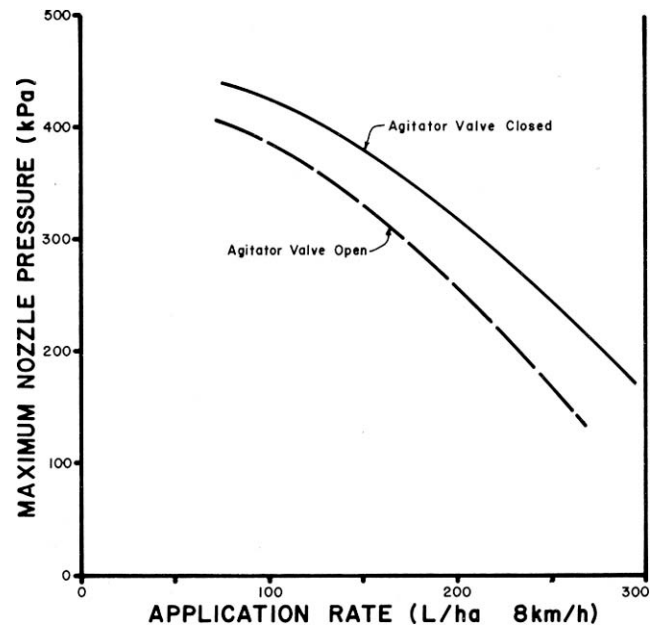
FIGURE 10 shows the maximum pressures available at the nozzle at various application rates when travelling at 8 km/h (5 mph). For example, with the agitator valve fully open, at a typical prairie application rate of 100 L/ha (9 gal/ac), the maximum nozzle pressure obtainable was 383 kPa (56 psi). Nozzle pressures below 200 kPa (29 psi) are not recommended due to poor distribution patterns that occur at low pressures when using standard flat spray nozzles. The maximum application rate obtainable with

the George White T610 at a pressure of 200 kPa (29 psi) was 233 L/ha (21 gal/ac). At 100 kPa (15 psi), the lowest pressure at which low pressure flat fan spray nozzles produce a good distribution pattern, the maximum obtainable application rate was 285 L/ha (26 gal/ac).

Closing the agitator valve resulted in increased nozzle pressure at the various application rates. However, for most chemicals, the agitator valve had to be fully opened to obtain the required agitation.

FIGURE 10. Maximum Available Nozzle Pressures at Various Application Rates at 8 km/h.

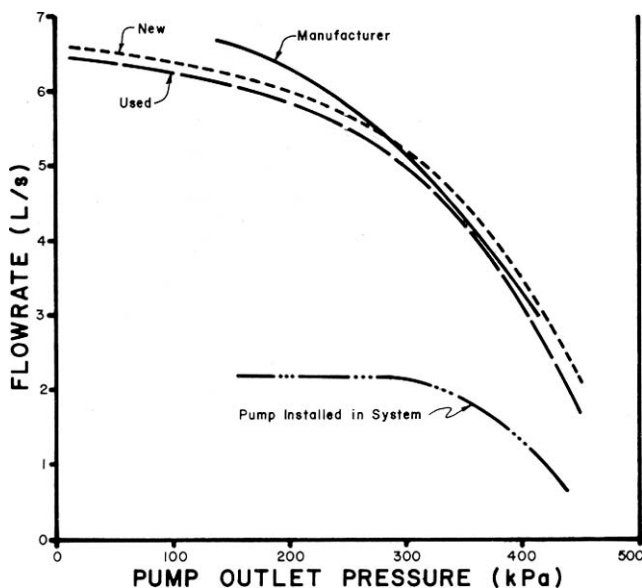
Output: FIGURE 11 gives the pump performance curves for the Hypro C9006 pump when operating at a power take-off speed of 540 rpm. Pump output was similar to the manufacturer's curve. Pump wear was negligible after 87 hours of operation.

FIGURE 11 also shows the pump performance curve for the Hypro C9006 pump when installed in the George White sprayer plumbing system. Even though the rated pump output was 6.6 L/s (87 gal/min), the maximum pump delivery available to the booms was only 2.2 L/s (29 gal/min) due to plumbing restrictions.

FIGURE 11. Pump Performance Curves at 540 rpm.

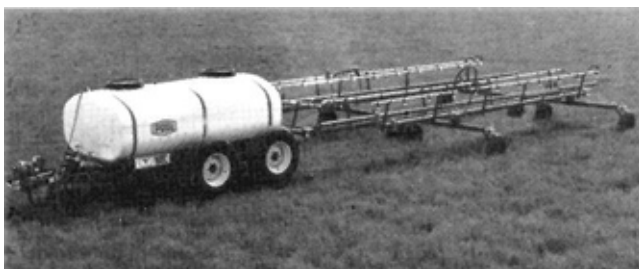
Transport: The George White sprayer could be folded into transport (FIGURE 14) or placed into field position in about 15 minutes with the use of a wrench. The weight on the spray boom height adjustment handle was too heavy to support by one person

FIGURE 14. George White T610 in Transport Position.

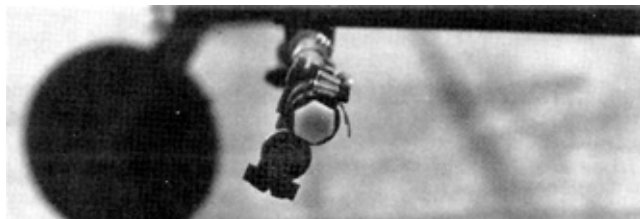
Nozzle Adjustment: Nozzle height was adjusted with the use of a wrench. The operator had to simultaneously adjust the height adjustment screw, rotate and hold the boom rails by means of the handle provided. This was difficult since the operator had to support the entire weight of the booms with one hand. Using the knee to rest the boom helped a little. Modifications are recommended to make boom height adjustment more convenient. Nozzle angle remained constant at all boom heights between 350 and 750 mm (14 and 30 in). Nozzle angle was conveniently changed by loosening five U-bolts and rotating the boom. In the field, the weight of the outer radius rods on the radius rod mounts caused the mounts to rotate downwards (FIGURE 17) which in turn caused the outer boom nozzle angle to change (FIGURE 19). It has already been recommended that modifications be made to eliminate this problem.

FIGURE 19. Nozzle Angle Pointing Back After Radius Mounts Shifted Downwards.

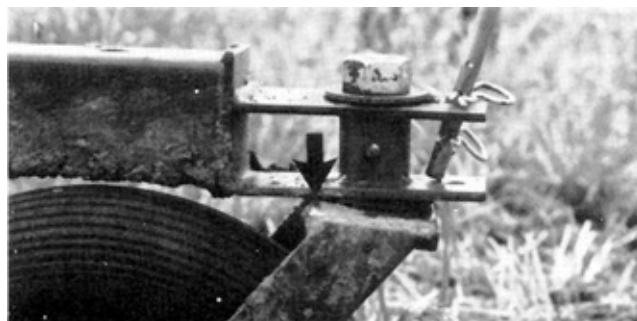
Castor Fork and Tandem Beam Weldment: Interference occurred between the castor fork and tandem beam weldment on all castor wheel assemblies (FIGURE 21). This resulted in the wheels not castoring properly and caused the tandem beam to rotate about the boom rail (FIGURE 22). When the tandem wheel rotated about the boom rail, damage occurred to the nozzle bodies, radius rod mounts, slow moving vehicle sign, radius rod connecting bars, castor forks, boom uprights and collars. The interference was eliminated by inserting washers on the vertical castor fork spindles between the castor forks and tandem beams.

FIGURE 21. Interference between Castor Fork and Tandem Beam Weldment.

15. The hitch frame has been modified.
16. A new design of outrigger tandem beams has eliminated failures of castor forks.
17. Welding on radius rods have been improved.

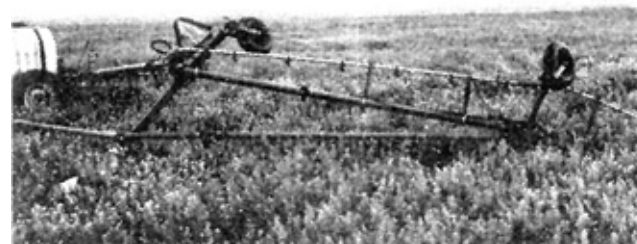
FIGURE 22. Rotation of Tandem Beam Assembly Around the Boom Rail.

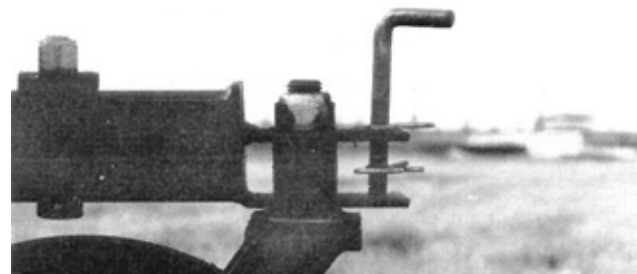
At the end of the test the manufacturer supplied a new castor fork and tandem beam weldment assembly (FIGURE 23). The new assembly worked well and only on one occasion did the tandem beam weldment rotate about the boom rail. This happened during a turn to the outer inside tandem beam when travelling over a rough cultivated field.

FIGURE 23. Modified Tandem Beam Assembly.
